Mathcad Analysis of Davidson Capacitor Bank Misoperation

Russell W. Patterson
Tennessee Valley Authority

Presented to the
Georgia Tech
2001 Fault and Disturbance Analysis Conference
May 1-2, 2001

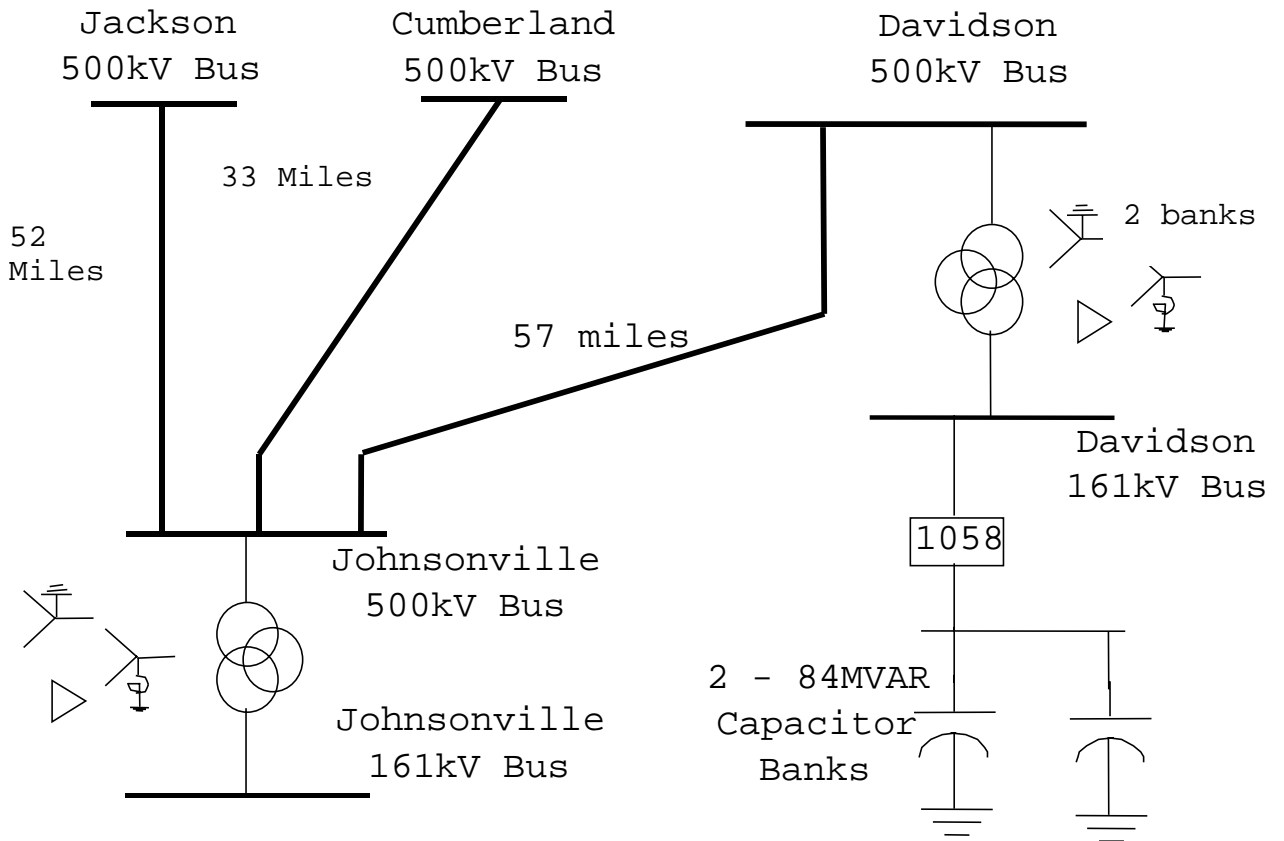
Figure 1. Single line of the network between Davidson and Johnsonville.

The Johnsonville Steam Plant 500kV intertie bank is comprised of single-phase three-winding units rated 240/320/400 MVA connected Yn-yr-d. The Davidson 500kV substation is electrically connected to Johnsonville via a 57 mile 500kV transmission line. There are two 500kV to 161kV intertie banks at Davidson (single-phase units) connected Yn-yr-d. One rated 180/360/400 MVA, the second rated 268.8/358.4/448. Both Davidson banks and the Johnsonville bank have 4.5 ohm reactors in the 161kV neutrals. The Davidson 161kV capacitor bank is comprised of two 84 MVAR capacitor banks with seven series groups per phase. Each series group is made up of 20 – 13.2kV, 200kVAR capacitor units. Figure 1 below shows the simplified single line.

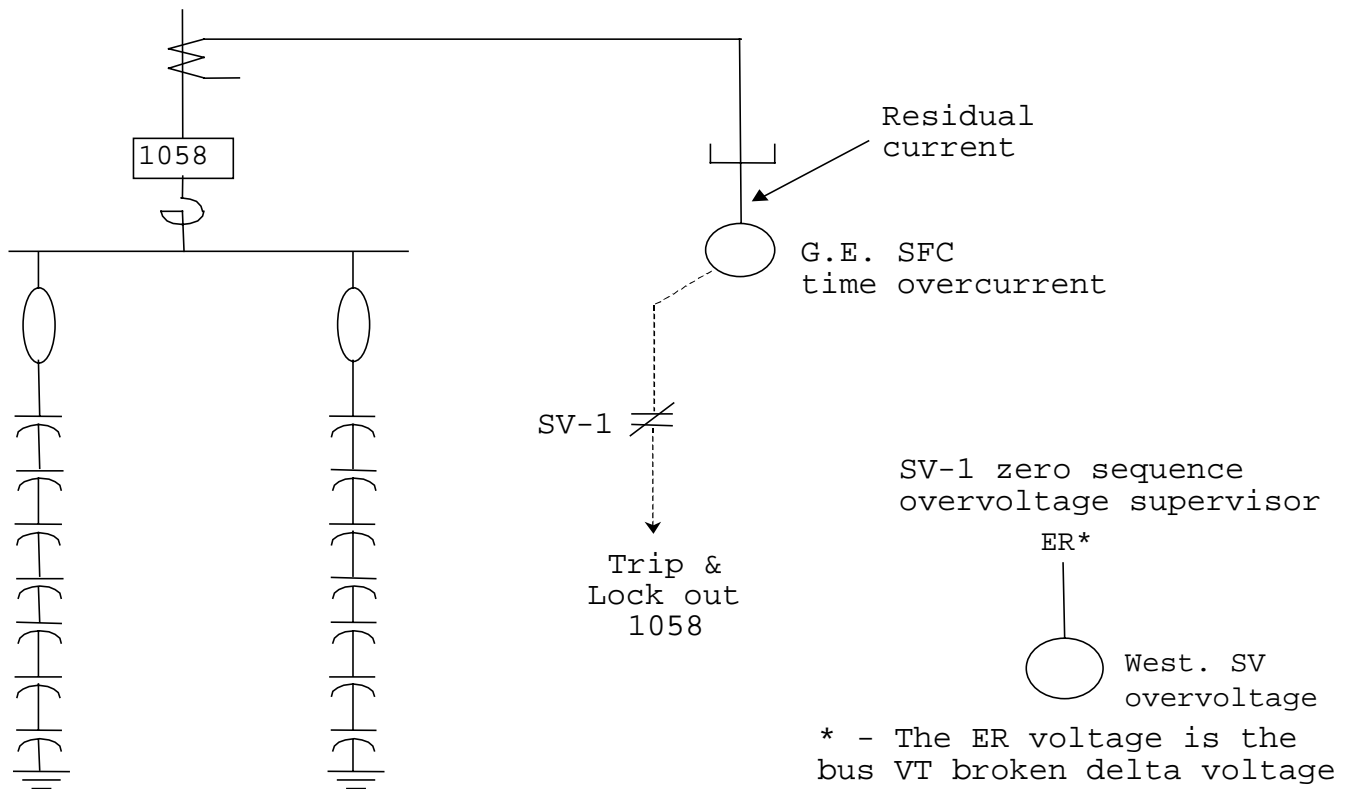
Figure 2. Single line of Davidson 161kV capacitor bank residual o.c. protection.

Part of the Davidson 161kV capacitor bank protection consists of the SFC (obsolete static type) overcurrent relay supervised by an SV (electromechanical plunger type) voltage relay. The SFC relay operates on the residual current from the capacitor bank breaker. This relay has a primary pickup of 38.4A with a time lever setting of 2 which results in the following characteristic curve:

The SV relay operates on zero sequence voltage from the broken delta connection of the 161kV bus PTs. Its pickup is 7,200V primary 3V0 at 60Hz. Figure 2 shows this relaying in single line form.

This scheme is designed to be a backup to capacitor unbalance protection and its overcurrent pickup is only marginally below the residual current that would flow due to the loss of one complete series group (seven groups parallel per phase, one group having 43A normal load current). The SFC is supervised by the SV zero sequence overvoltage relay to prevent its operation on normal zero sequence current from the capacitor bank that flows when 161kV system ground faults occur. The zero sequence voltage that is produced by system ground faults is significantly higher than the zero sequence voltage present due to capacitor bank unbalances, thus allowing discrimination between the two. The zero sequence voltage on the bus due to unbalance in the grounded wye capacitor bank can be simply calculated by taking the zero sequence current from the bank and multiplying times the zero sequence thevenin equivalent at the bus (e.g. If you have 10A in the capacitor bank neutral and the zero sequence thevenin at the bus is 9Ω the zero sequence voltage will be $10/3 \times 9 = 30V$). Alternatively, you can abuse yourself by solving a networks problem with the sequence equivalent of the unbalanced capacitor bank² which produces the same result.

The SV relays voltage pickup is typically set 150% below the lowest zero sequence voltage present for line end ground faults. In general this is significantly above the unbalance present for one complete phase open on the capacitor banks. This supervision allows a low residual overcurrent pickup setting while providing security against misoperation on 161kV ground faults. This scheme operated at Davidson when the Johnsonville Steam Plant 500kV intertie bank was energized with A-phase on the wrong voltage tap.

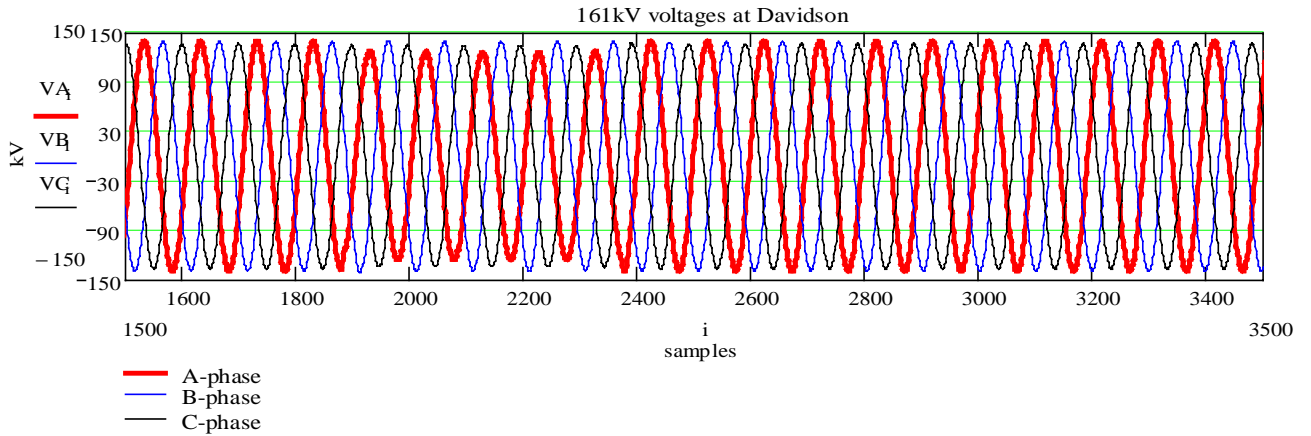
Figure 3. A-phase voltage dips during ground fault event (heavy trace).

format and imported into Mathcad for analysis. Below, in Figure 3, is a plot of the three 161kV bus voltages. A noticeable dip in A-phase can be seen around the 2000 sample mark.

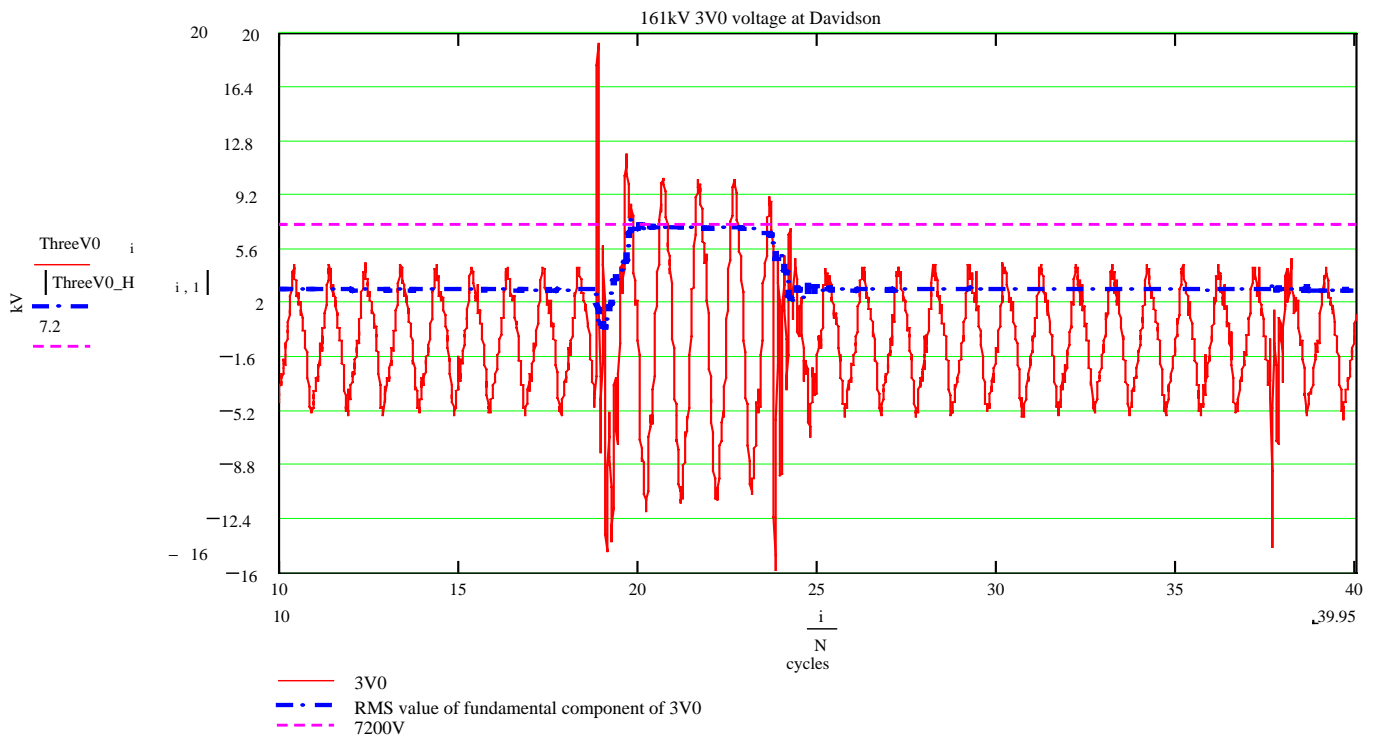
Figure 4. Graph of 161kV 3V0, RMS of fundamental component, and SV pickup.

The next figure shows the sum of the three phase-neutral voltages ($V_A + V_B + V_C = 3V_0$). The horizontal line is the 7200V line marking the RMS level of zero sequence voltage required to operate the SV voltage relay at 60Hz. The trace that travels just below this 7200V threshold during the event is the RMS value of the fundamental component of the $3V_0$ voltage.

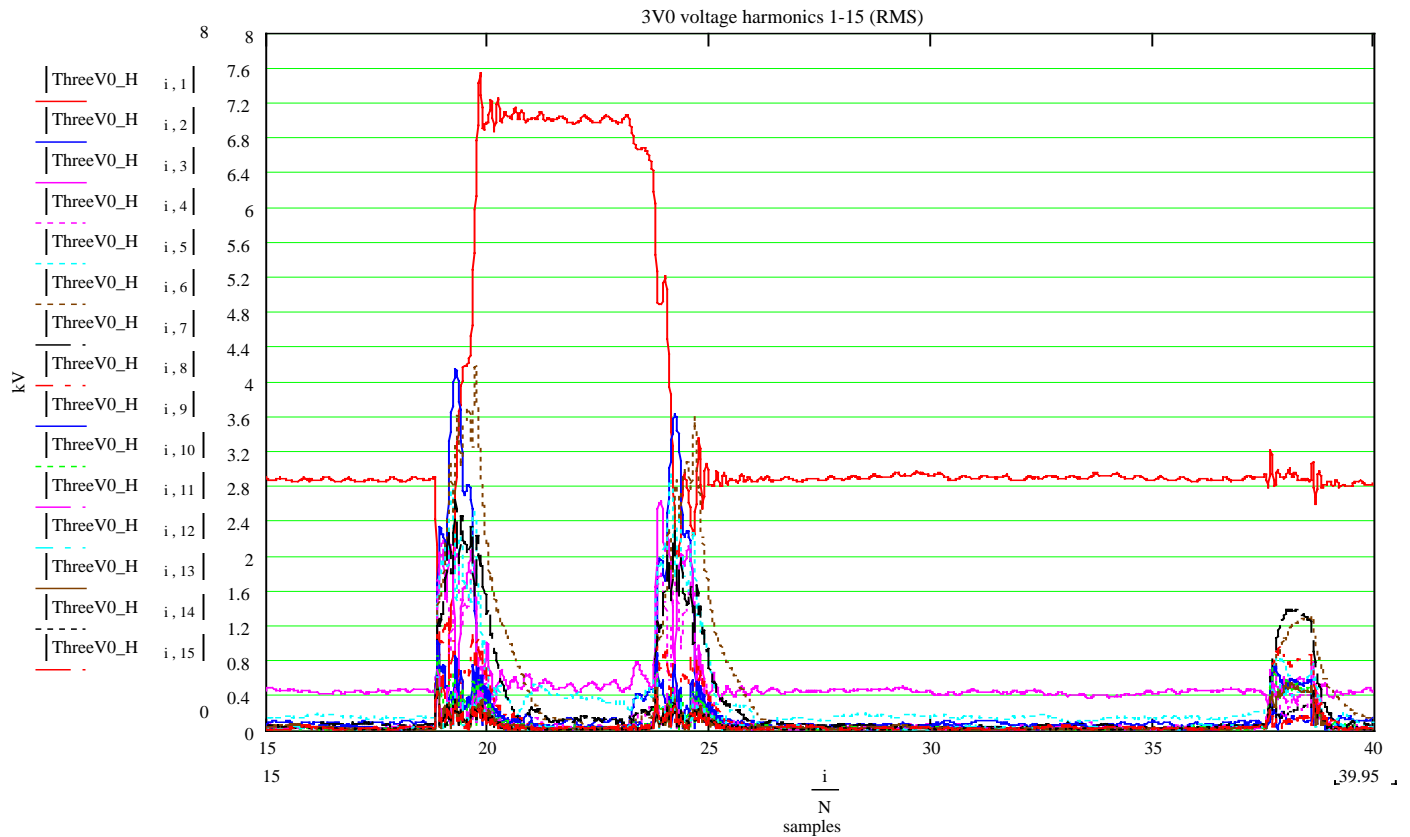
Figure 5. Harmonics 1 through 15 of the 3V0 voltage (RMS values).

The instruction book for the SV relay indicates that this relays pickup is proportional to frequency. In other words, if the frequency goes up by a factor of 1.25 the pickup voltage increases by that same factor. So, if the relay is set to pickup at 7200V at 60Hz it will pickup at 14,400V at 120Hz. In Figure 5 a plot of the first 15 harmonics of the 3V0 voltage are shown. Figure 6 shows the harmonics that are most significant in magnitude during the 5 cycles of the event.

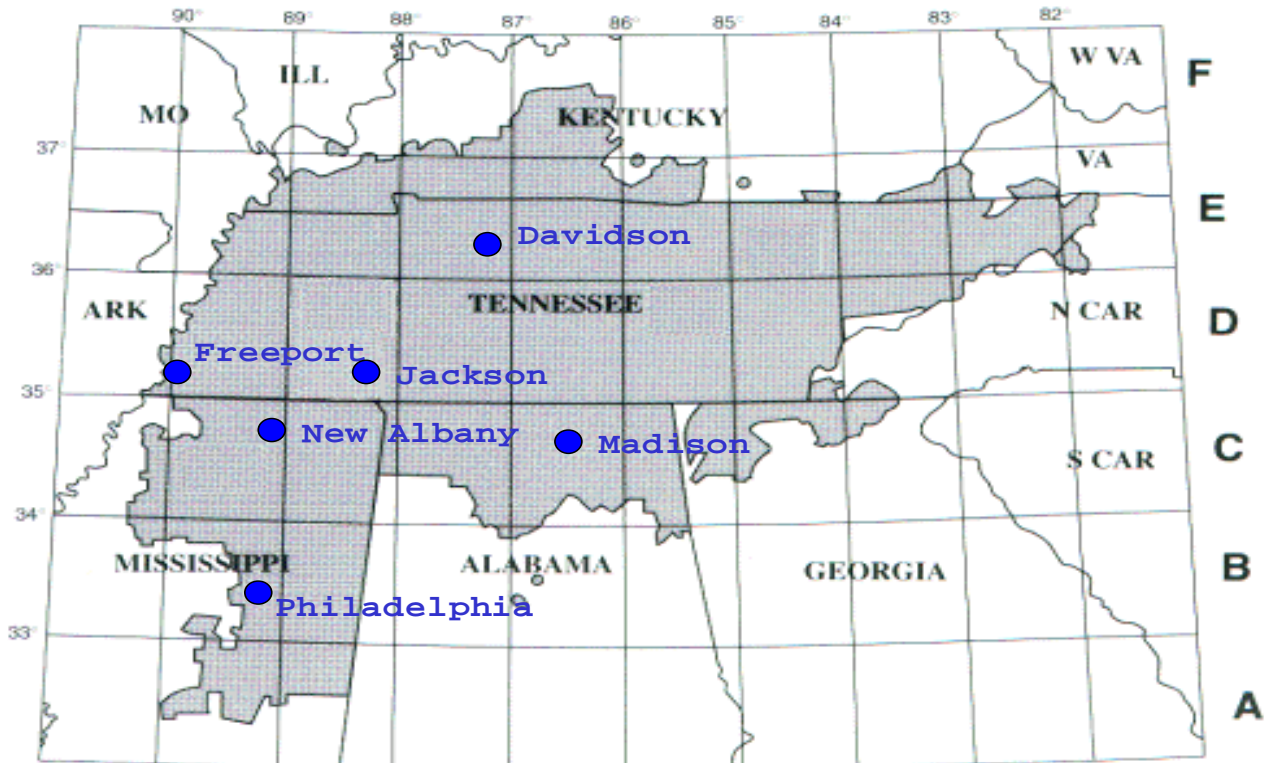
Figure 7. Geographic dispersal of simultaneous capacitor bank trips by SFC relay.

It can be seen that several of these capacitor bank trips at different locations occurred simultaneously. These locations are separated by hundreds of miles (see Figure 7) as calculated from longitude and latitude⁴.

A quick look at the NASA space weather website⁵ showed that one of the largest solar storms in a decade had occurred prior to this event and was the most likely candidate for the subsequent geomagnetic activity. During a geomagnetic event quasi-DC currents are induced in the earth. These currents find a path up the neutrals and over the transmission lines of our transmission systems. When these DC currents flow in transformers they can produce varying degrees of half-wave saturation. The saturation produces harmonics that find a convenient path to ground through the capacitor banks. This is a problem for the capacitor banks because they are absorbing harmonic energy. The following is an excerpt from a working group draft of IEEE 1036 (as of July 2000):

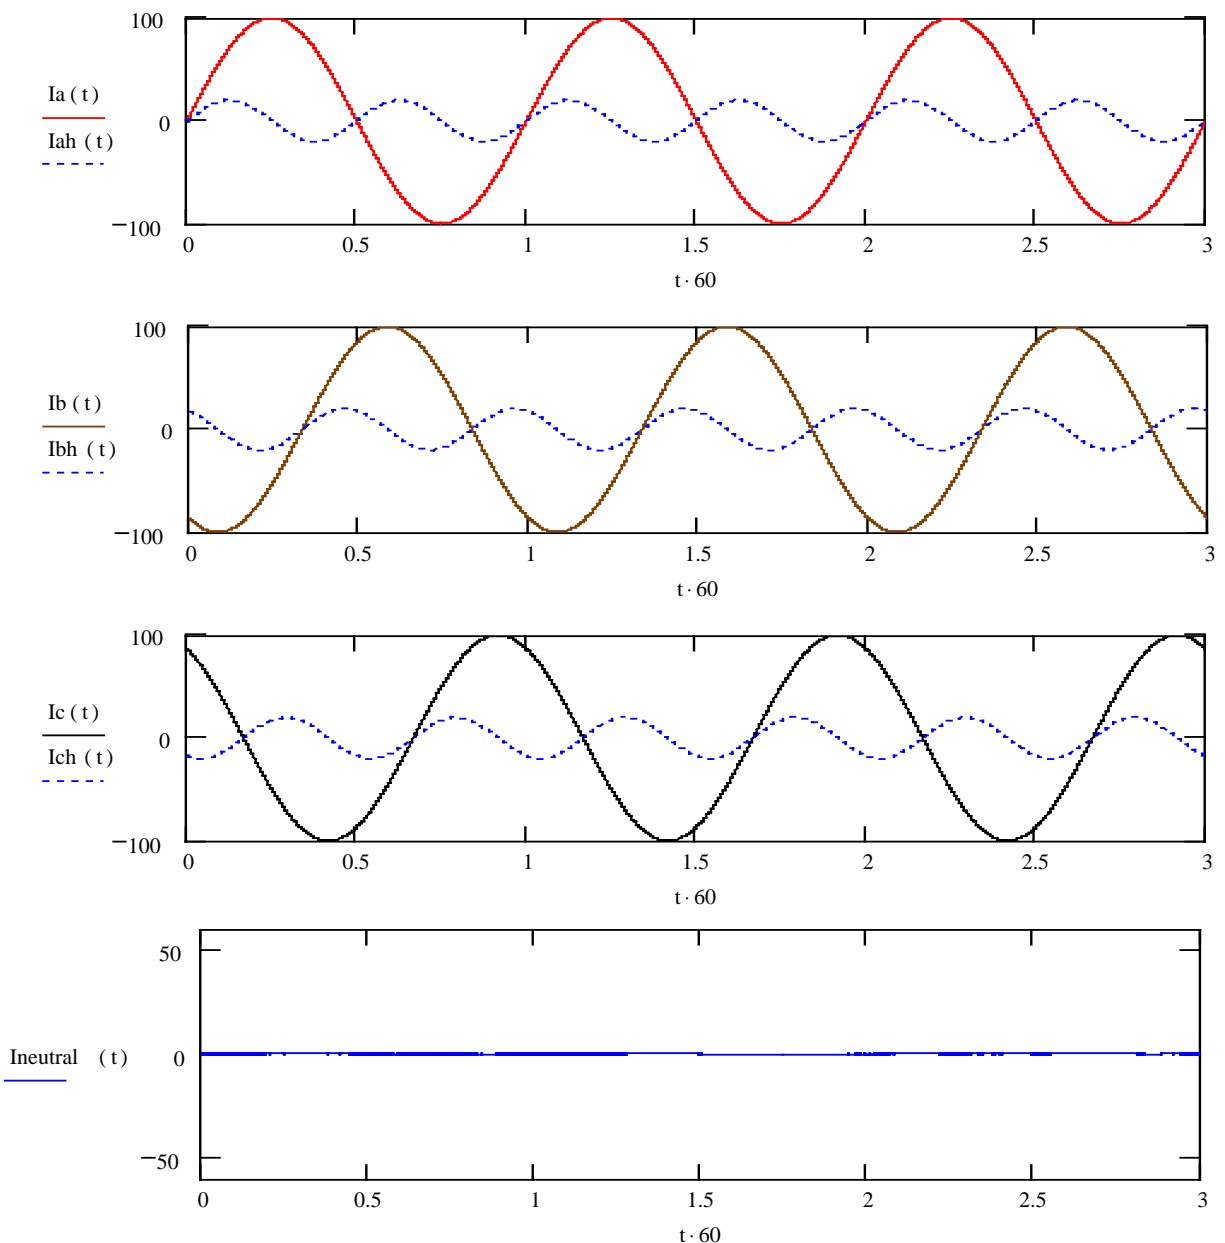
The harmonics of 60Hz that behave as positive sequence are 1, 4, 7, 10, 13, etc. Those that behave as negative sequence are 2, 5, 8, 11, 14 etc. Those that behave as zero sequence (sum in the neutral) are 3, 6, 9, 12, 15 etc. and are also referred to as “triplen” harmonics⁶. This behavior depends on the harmonics being generated symmetrically across the three phases (magnitude and relative phase angle). Below are 3 cycle plots of A, B, and C 60Hz phase currents along with a 20% 2nd harmonic that might be superimposed on these currents. The 2nd harmonic is a negative sequence harmonic so the three components in each phase sum to zero at the neutral. Note that the harmonic energy is symmetrical across the phases because they have the same magnitude and phase angle relative to each 60Hz phase current.

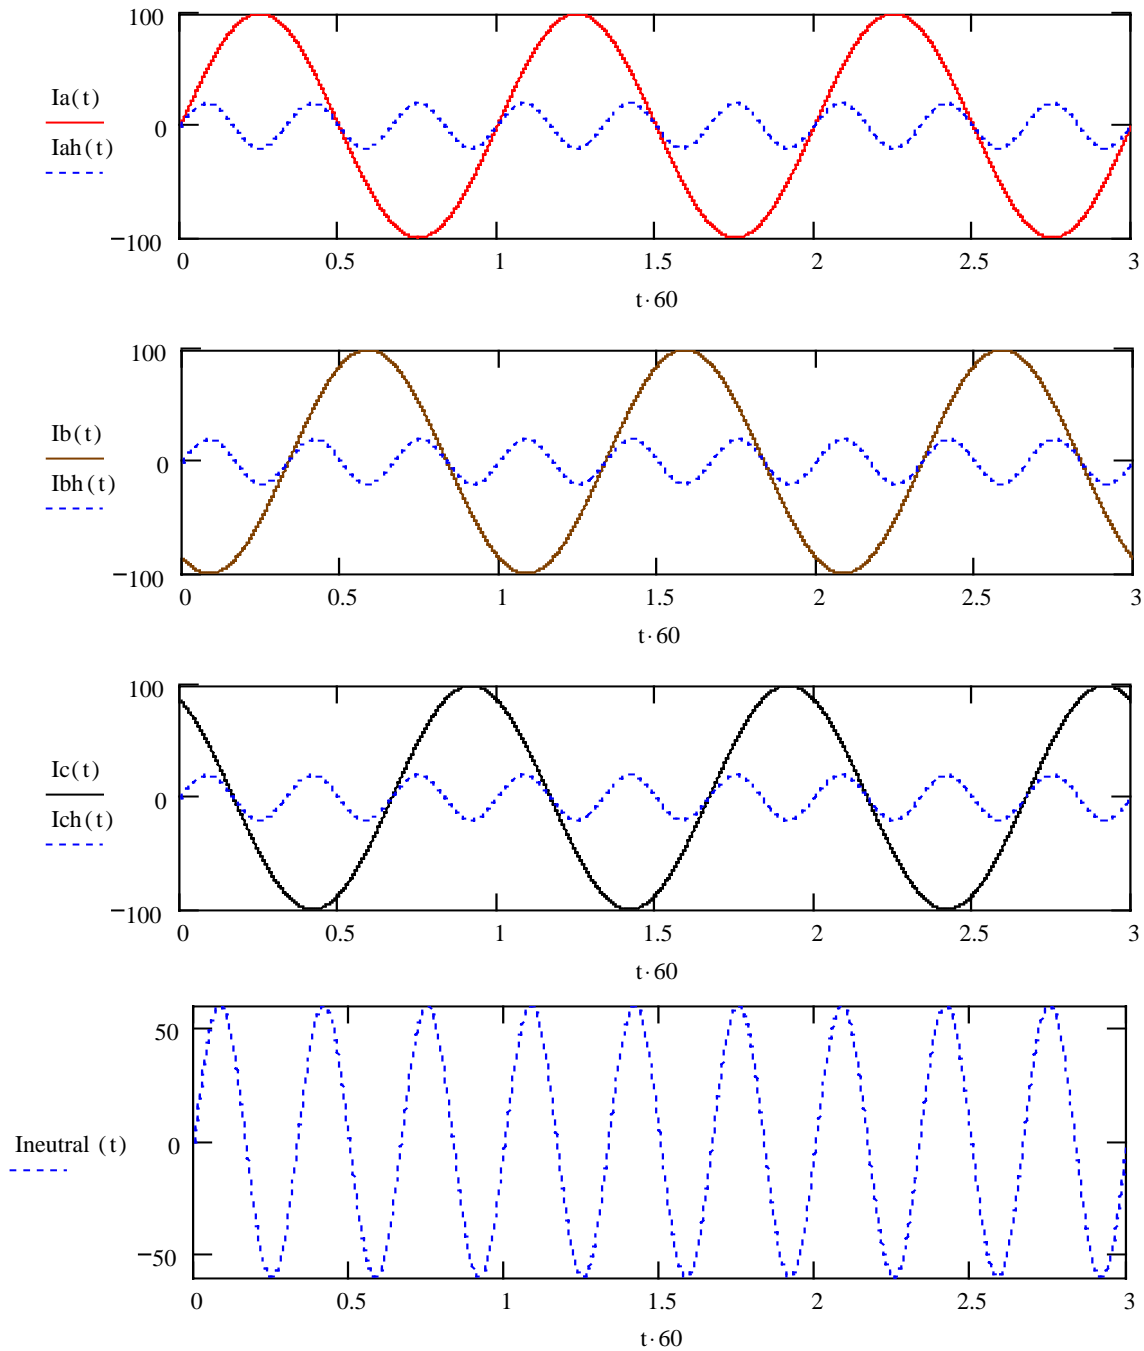
Below are 3 cycle plots of A, B, and C 60Hz phase currents along with a 20% 3rd harmonic that might be superimposed on these waveforms. The 3rd harmonic is a zero sequence (triplen) harmonic so the components in each of the three phases sum to three times in the neutral.

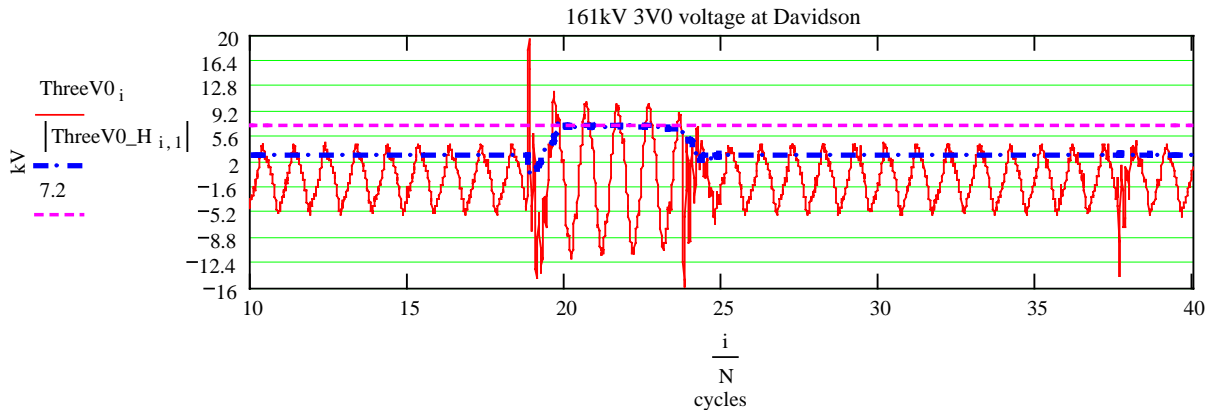
<-- The equation with the summation symbol is where the work is being done. This formula performs the discrete Fourier transform using a "sliding" window of 100 data points. This is done for fundamental through the "h" harmonic. Since the results of this are in peak magnitudes the RMS values are obtained by dividing by root 2.

Some explanation is in order for the "sliding DFT" being used. The digital Fourier transform is meaningful when you have enough samples to create one complete cycle of the fundamental waveform. In this case we require 100 samples to make one waveform since the fundamental is 60Hz. The "sliding" comes in because this routine takes the first 100 data points and spits out the harmonic content, then it drops off the first data point and adds in the 101st data point. In this manner it "slides" down the waveform spitting out harmonic content values with a 100 data point wide window. This next Mathcad file creates the harmonic plots to

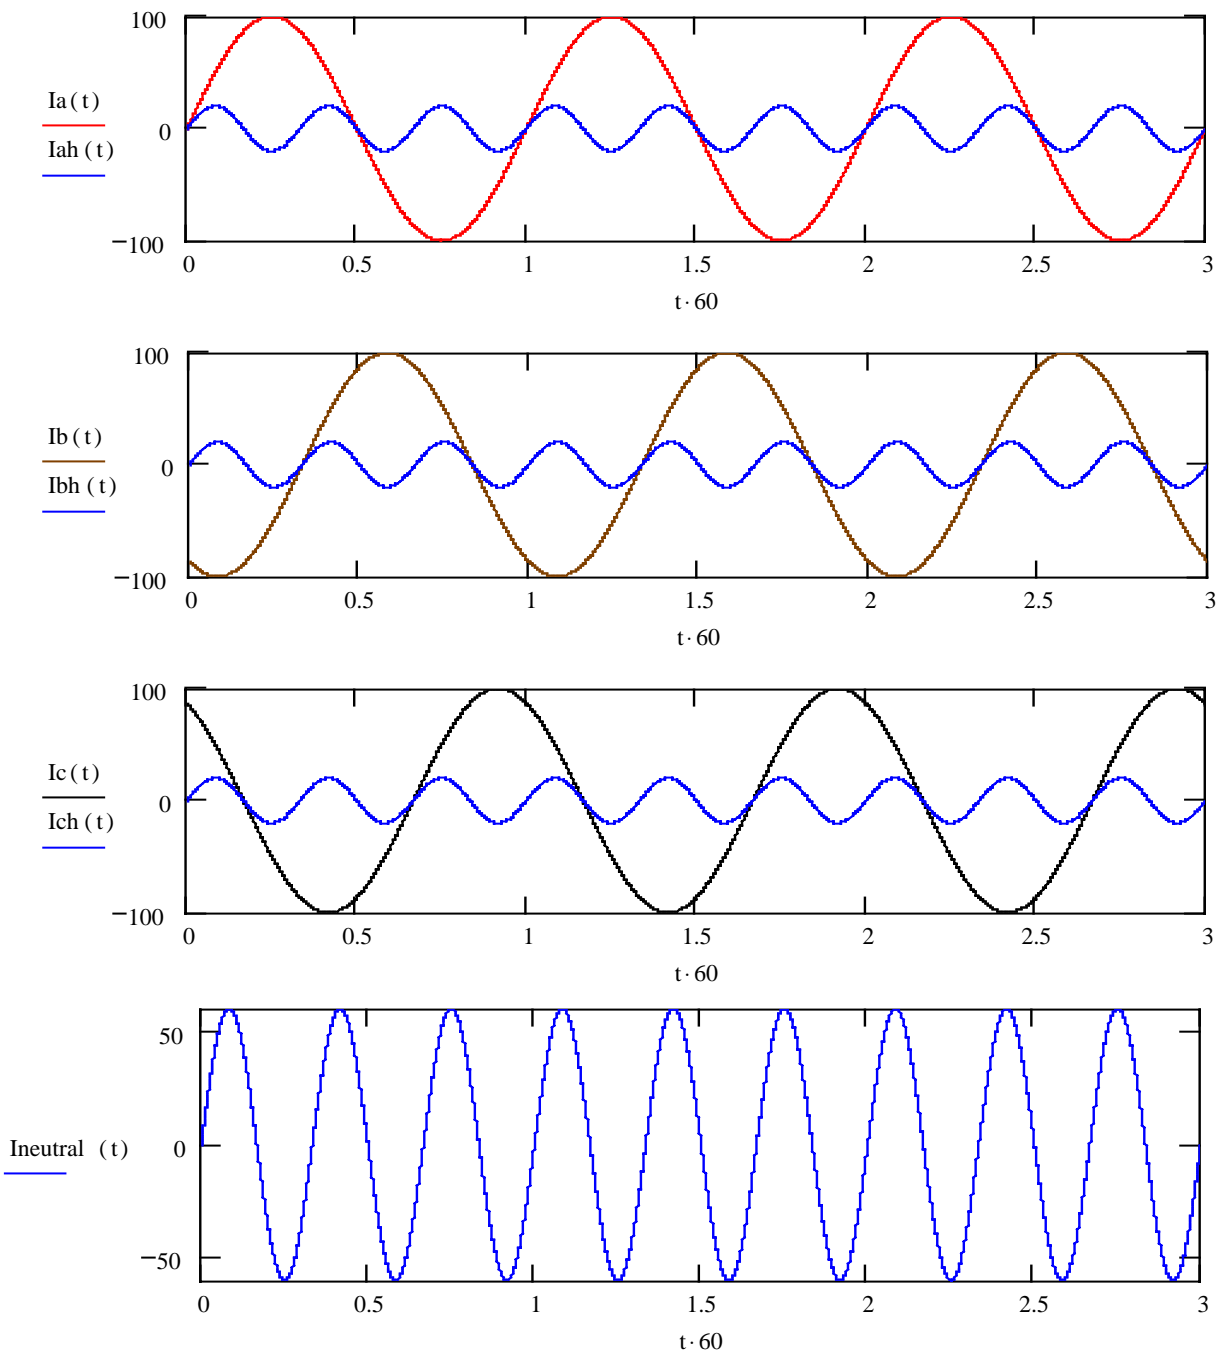
demonstrates the positive, negative, and zero sequence behavior of symmetrical harmonics. A is the magnitude of the fundamental used, H is the magnitude of the harmonic used, and h is the harmonic number (3rd harmonic in this particular case).

$$I_{neutral}(t) := I_{asum}(t) + I_{bsum}(t) + I_{csum}(t)$$
